Application Notes

Automotive Console Face Plate Inspection

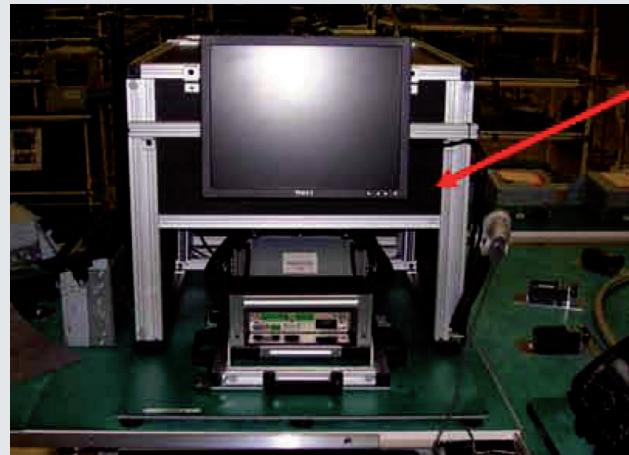
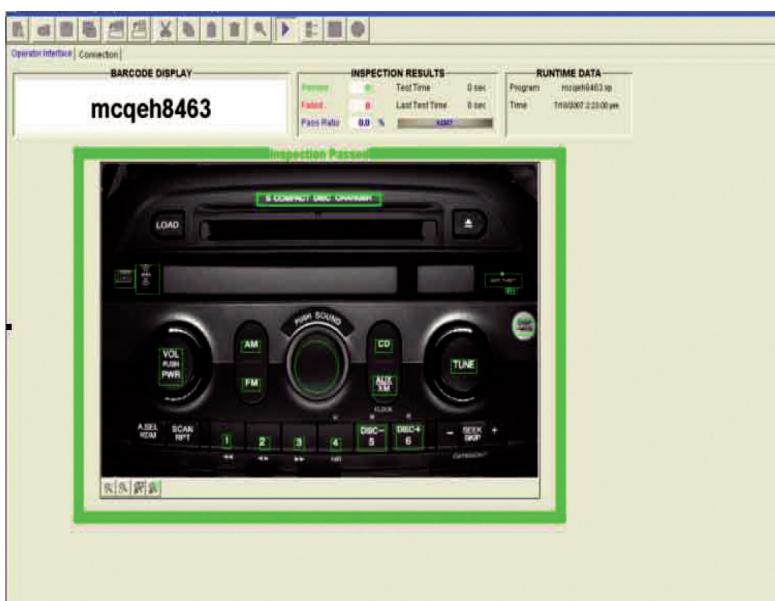
A fully enclosed system with camera lighting and PC within

In order to provide an even coverage over the curved surface of the face plate, the inspection is done in an enclosed box with two diffused bar lights mounted above the part. This is a stand-alone system with cameras, lighting, optics, PC and various communication and electrical components enclosed. The system is also designed to accommodate additional devices within the same inspection cell for additional inspection requirements. The communication links to the SQL server is made possible through custom software and composite tools designed by Datalogic application engineers.
